Calvert-St. Mary's
Metropolitan Planning Organization's

Bus Stop Assessment and Plan

Final Report
September 2019

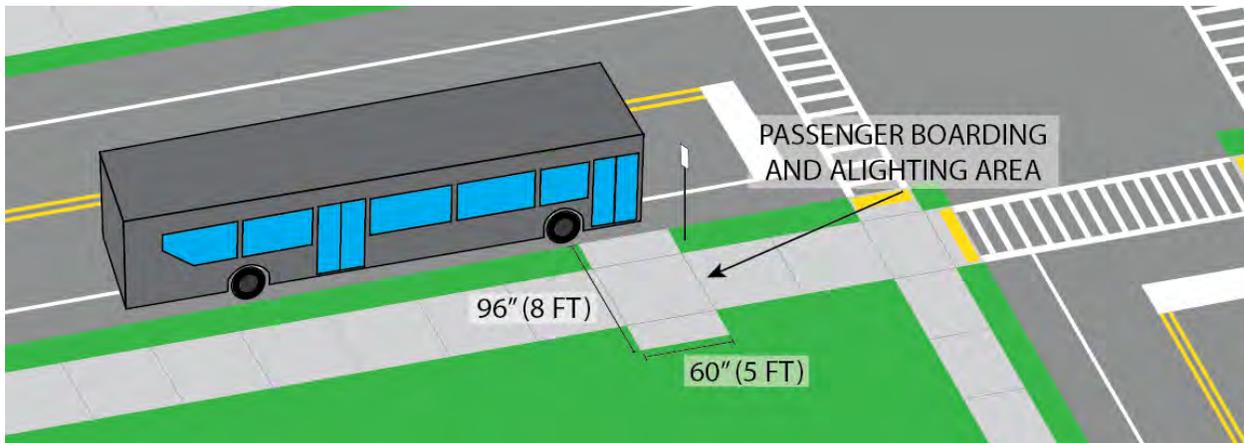
Figure 1-1: ADA Compliant Passenger Boarding and Alighting Area

- Surface** Boarding and alighting areas shall have a firm and stable surface
- Dimension** Boarding and alighting areas shall extend a minimum of 96 inches deep and 60 inches wide
- Connection** Boarding and alighting areas shall be connected to streets, sidewalks, or pedestrian paths by an accessible route
- Slope** Parallel to the roadway, the slope shall be the same as the roadway
Perpendicular to the roadway, the slope shall be no steeper than 1:48 (approx. 2%)

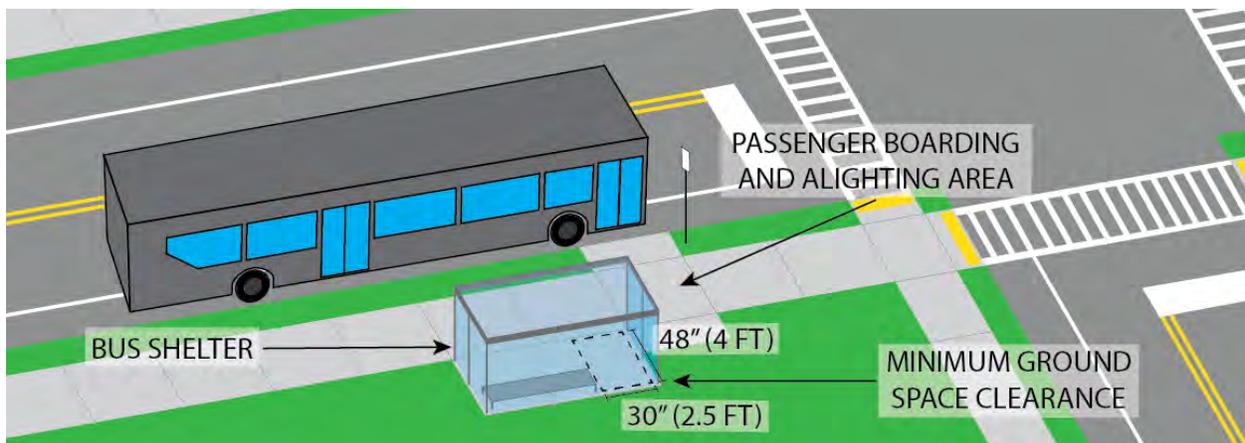
Figure 1-2: ADA Compliant Bus Stop Shelter

Connection	Bus shelters shall be connected by an accessible route to an accessible boarding and alighting area
Ground Space Clearance	Bus shelters shall provide a minimum clear floor or ground space entirely within the shelter
Surface	Floor or ground surfaces shall be firm and stable; changes in level are not permitted
Dimension	Clear floor or ground surfaces shall be a minimum of 30 inches by 48 inches
Position	Floor or ground space shall be positioned to accommodate a forward or parallel approach
Maneuvering Clearance	<p>Where floor or ground space is located in an alcove or otherwise confined on all or part of three sides, additional maneuvering clearance shall be provided</p> <p><u>Forward Approach:</u> Alcoves shall be a minimum of 60 inches wide where the depth exceeds 24 inches</p> <p><u>Parallel Approach:</u> Alcoves shall be a minimum of 60 inches wide where the depth exceeds 15 inches</p>

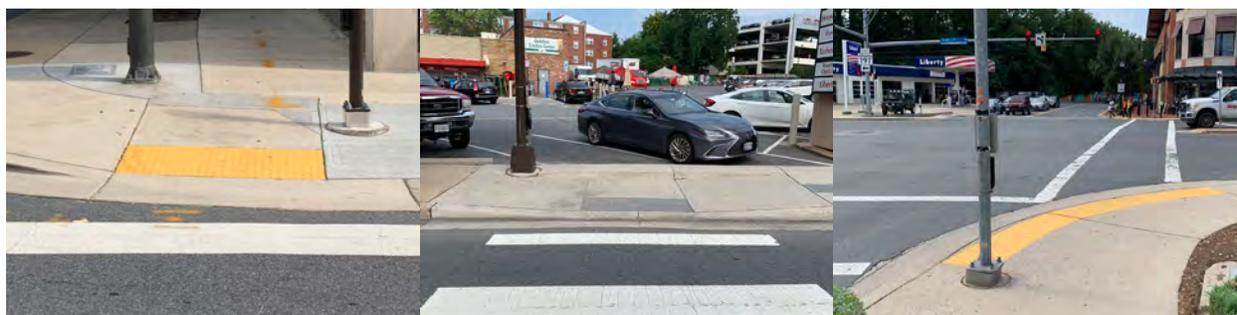
Figure 1-3: Examples of Curb Ramps and Blended Transitions

Perpendicular curb ramps are perpendicular to the street curb and permit pedestrians to cross the street perpendicular to vehicular traffic. Ideally, they are in line with the path of travel of both the sidewalk and the street crossing, but this is not always possible due to existing conditions. A common distinguishing feature of perpendicular curb ramps is that each ramp generally serves a single street crossing; at a four-way intersection, two perpendicular ramps are needed at each corner.

An alternative approach to curb ramps is a category of treatment referred to as a blended transition. A blended transition is a raised pedestrian street crossing, depressed corner, or similar level connection between the pedestrian pathway and the pedestrian street crossing. Blended transitions are commonly used in locations with high pedestrian activity.

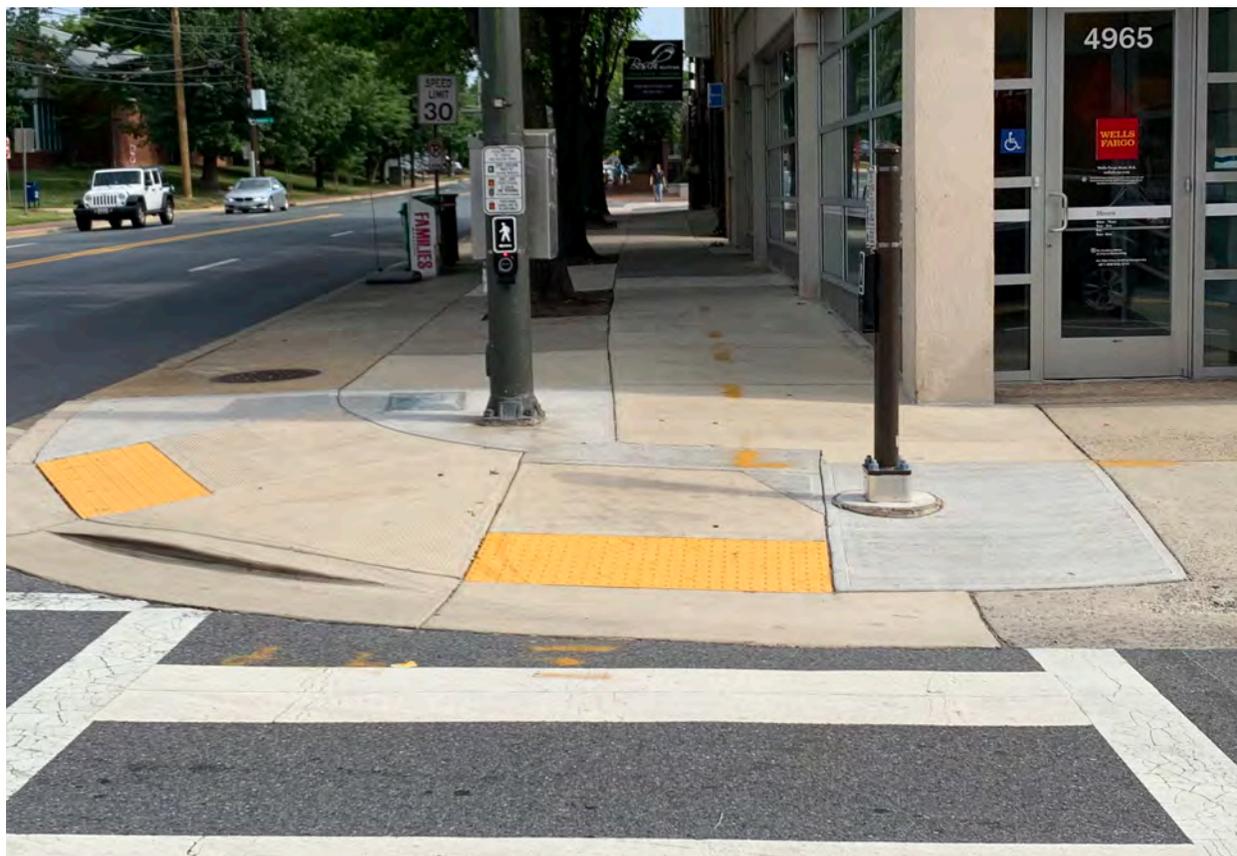
Figure 1-4: Example of Detectable Warning Surfaces

Detectable warning surfaces are not required at pedestrian refuge islands that are cut-through at the street level and are less than six feet in length in the direction of pedestrian travel.

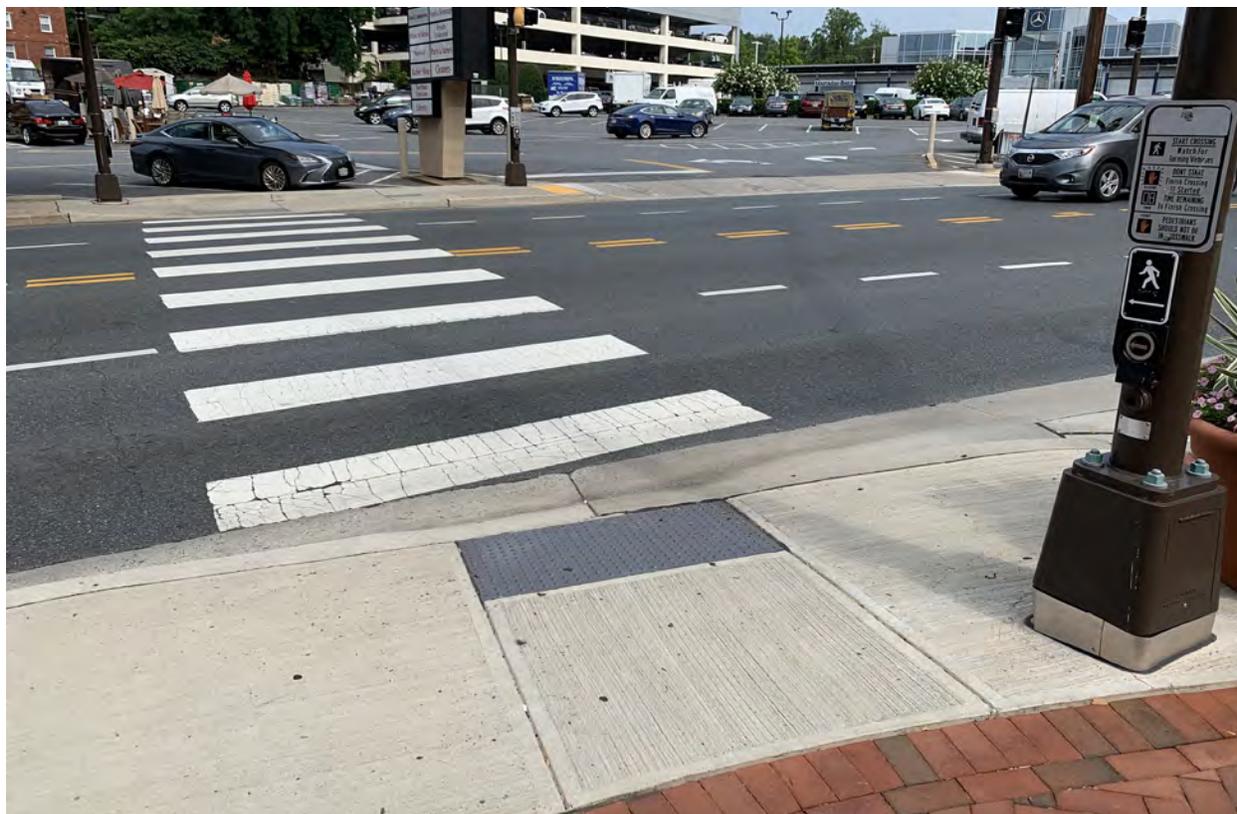
Figure 1-5: Example of an ADA Compliant Pedestrian Street Crossing

There needs to be a clear space adjacent to the pushbutton, connected to the pedestrian pathway, and the pushbutton must be mounted within a height range (15” to 48” from the surface) that makes it reachable for wheelchair users. The clear space must have a firm, stable, and slip resistant surface, with a running slope that is consistent with the grade of the adjacent pedestrian access route and a maximum cross slope of 2 percent. It must be a minimum of 48 inches by 30 inches and must be positioned to allow either forward or parallel approach to the pushbutton.

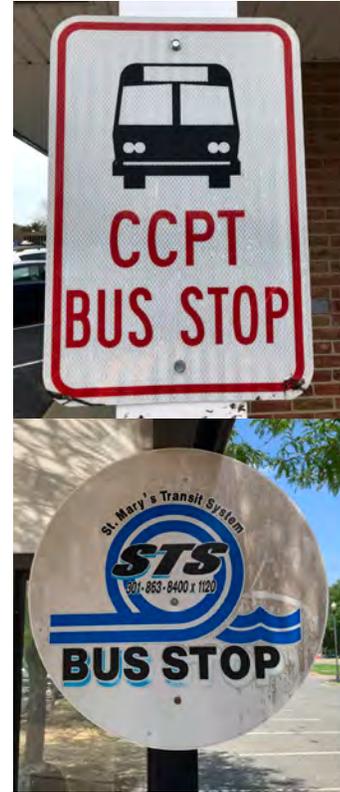
Figure 2-3: Bus Stop Signs

Of the 106 surveyed stops, only four had any signage indicating that the respective transit provider stopped there. Of the four, three of the stops were served by STS, while the remaining stop was served by CCPT. The three STS signs were attached to shelters, while the CCPT sign was attached to a column outside the Southern Branch of the Calvert County Library System. The rest of the stops were unmarked flag stops.

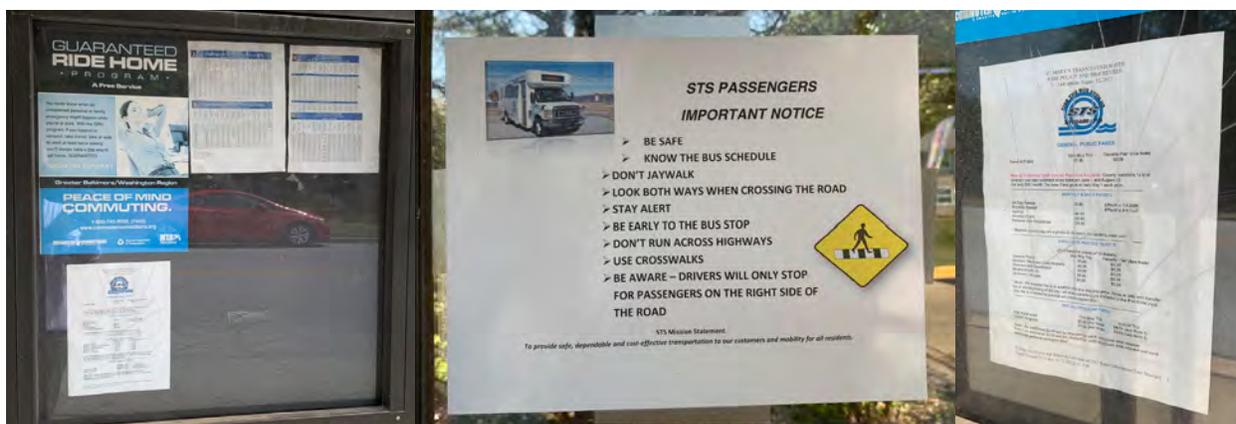
Figure 2-4: Information Cases and Information

Of the 106 observed stops, two had information cases. All stops with information cases were located in shelters served by STS. Each case was a one sided rectangular glass panel. They both included route schedules, fare information, and contact information. One case was damaged with visible scratches on the glass panel.

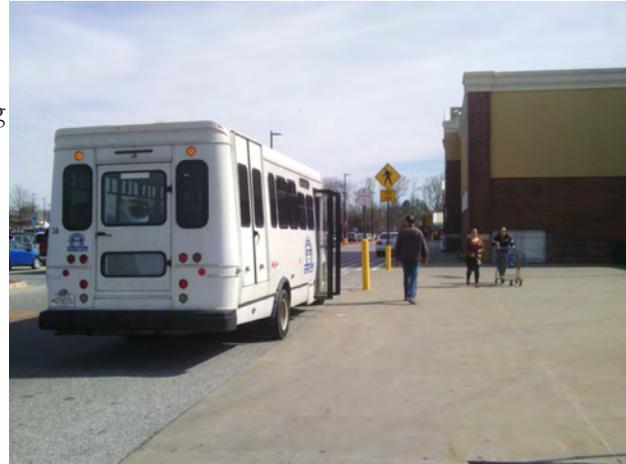
Figure 2-5: Landing Pad

In total, 22 of the 106 bus stops had a compliant, unobstructed landing pad that was connected to both the curb and a paved walkway. Further details about the inventoried landing pads can be found in Table 2-4.

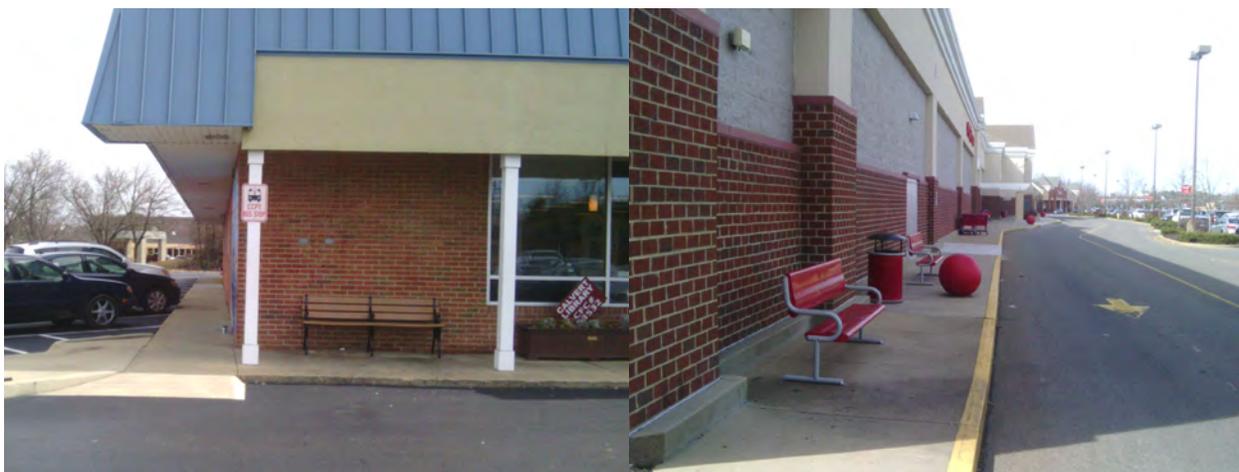
Figure 2-6: Bus Stop Benches

A total of 17 stops within the C-SMMPO have at least one bench for waiting riders. Twelve of the benches are freestanding, while the remaining five were located under a shelter. None of the inventoried benches had any damage. Most stops with benches were located at important shopping centers like the California Target and the Lusby Giant. Table 2-5 includes detailed statistics about the observed benches.

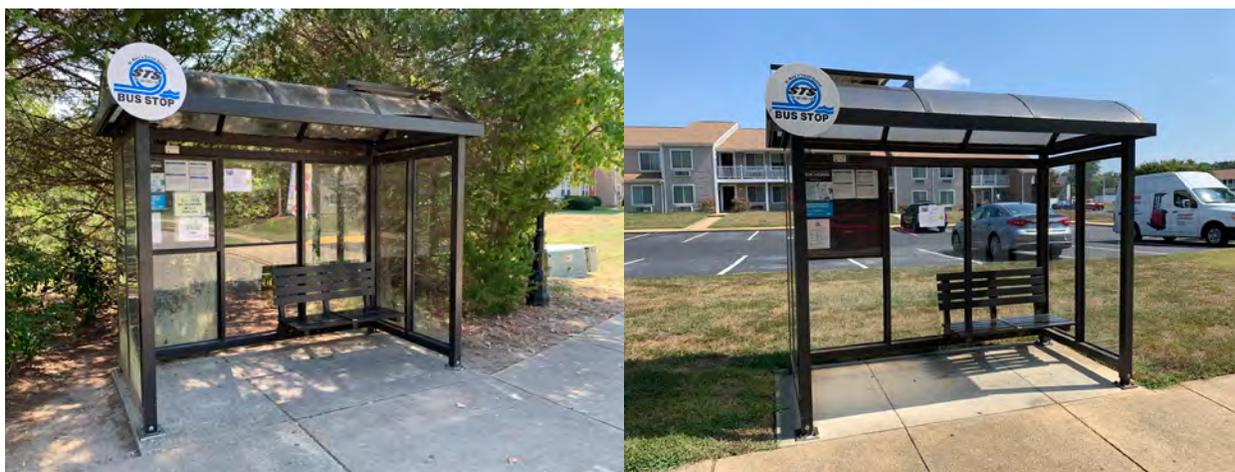
Figure 2-7: Bus Shelters

Five shelters were observed during the field survey. Each shelter featured interior seating, and three shelters had concrete foundations, while the other two had dirt or brick foundations. None of the shelters had any advertisements, and only one of the shelters had damage, from graffiti. One shelter was deemed inaccessible because its entrance was blocked by a bench. Table 2-6 outlines the statistics for the shelters observed during the survey.

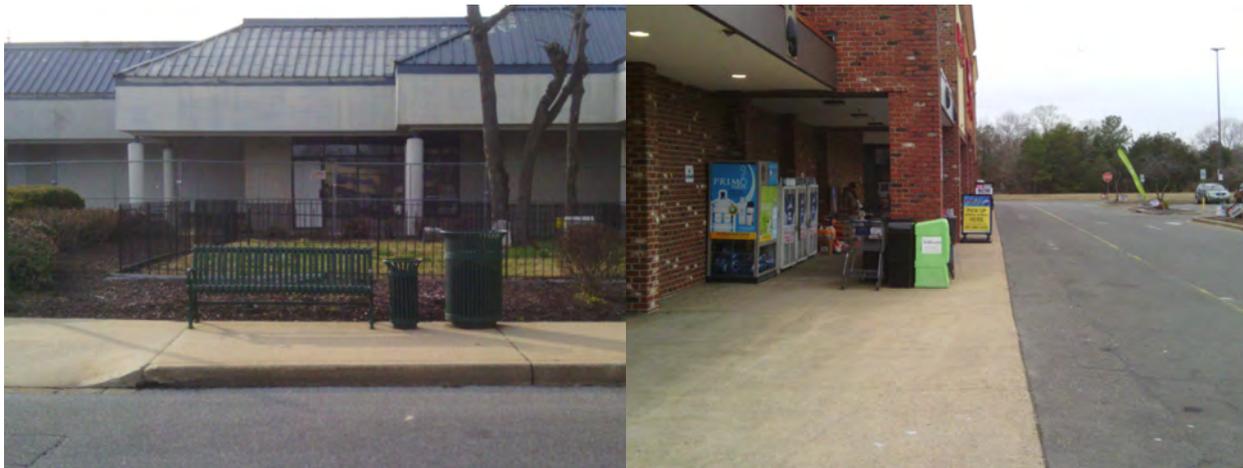
Figure 2-8: Other Bus Stop Amenities

Some bus stops have other amenities in addition to information cases, benches, and shelters. Trash receptacles, the most common of these amenities, were present at 16 bus stops. Beyond trash receptacles, four stops had bicycle racks and one had publication boxes. Table 2-7 breaks down the distribution of these amenities at the inventoried stops.

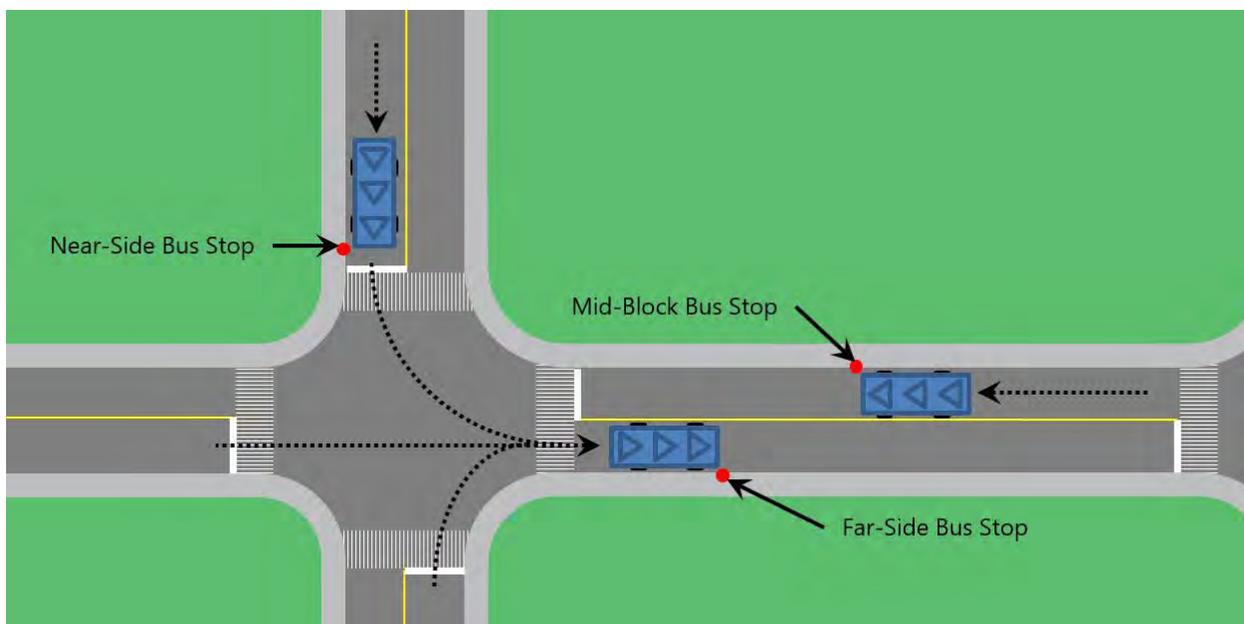
Figure 3-1: Bus Stop Placement Categories

Bus stops are largely centered around intersections due to the greater likelihood of safe and accessible pedestrian infrastructure including curb ramps, crosswalks, and pedestrian signals. However, the best placement will depend on vehicle and pedestrian travel patterns at the intersection, right-of-way availability, bus routing, pedestrian facilities, and other conditions at the site. The advantages and disadvantages of each type of bus stop location are provided in Table 3-1.

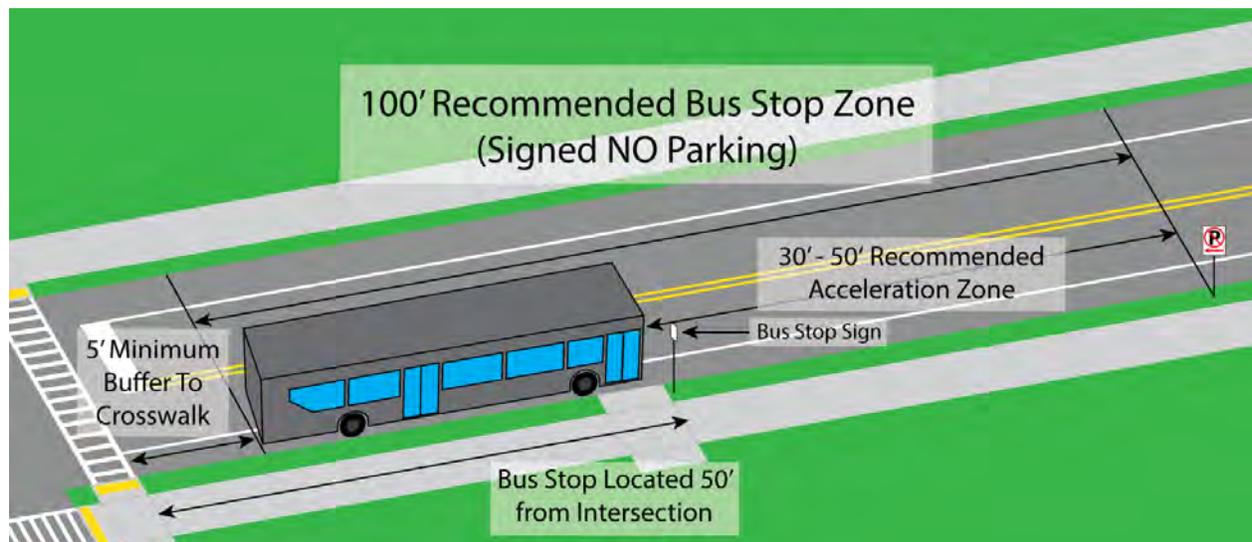
Figure 3-3: Far-Side Bus Stop Design Considerations

- Install a 100' bus stop zone with enforceable no parking signs
- Locate the bus stop at least 50' after the intersection to ensure the bus does not extend into the intersection and/or straddle the pedestrian crosswalk
- Provide a 5' buffer between the stopped bus and crosswalk/intersection
- Provide a 30' to 50' acceleration zone after the bus stop

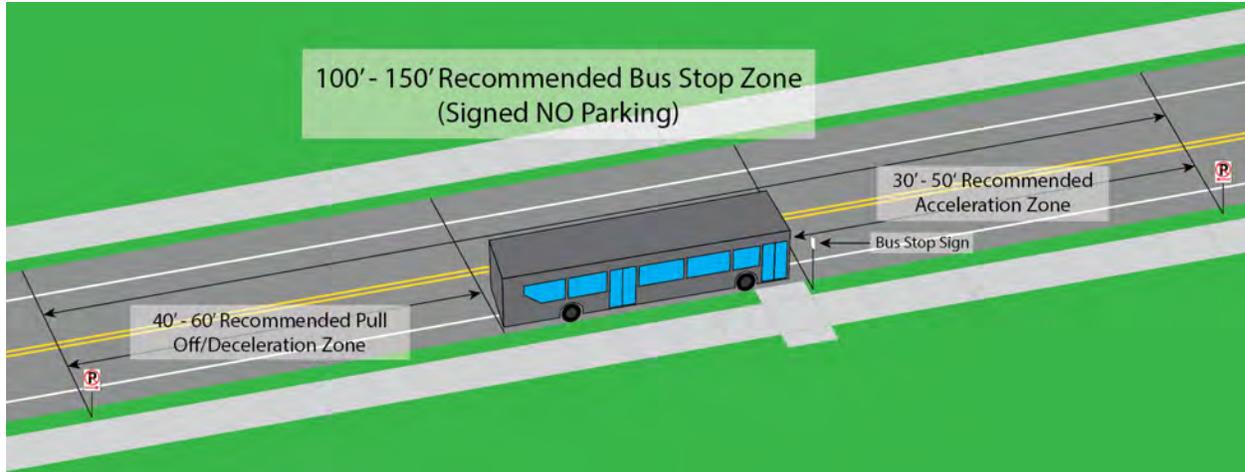
Figure 3-4: Mid-Block Bus Stop Design Considerations

- Install a 110' to 150' bus stop zone with enforceable no parking signs
- Provide a 40' to 60' pull off/deceleration zone before the bus stop
- Provide a 30' to 50' acceleration zone after the bus stop

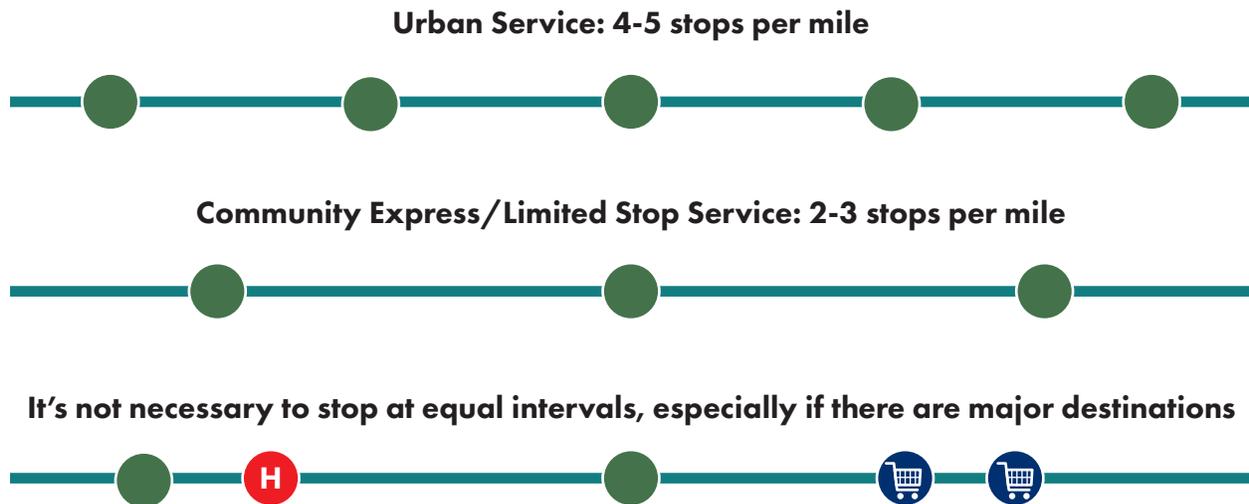
Figure 3-5: Bus Stop Spacing Guidelines

The guidelines shown in Figure 3-5 are recommended for service in the C-SMMPO region. The spacing guidelines are only a guide. The addition or elimination of bus stops should take into account existing transit needs, trip generators, land uses, and pedestrian infrastructure. All bus stops need to have adequate sidewalk connections and intersection crossings.

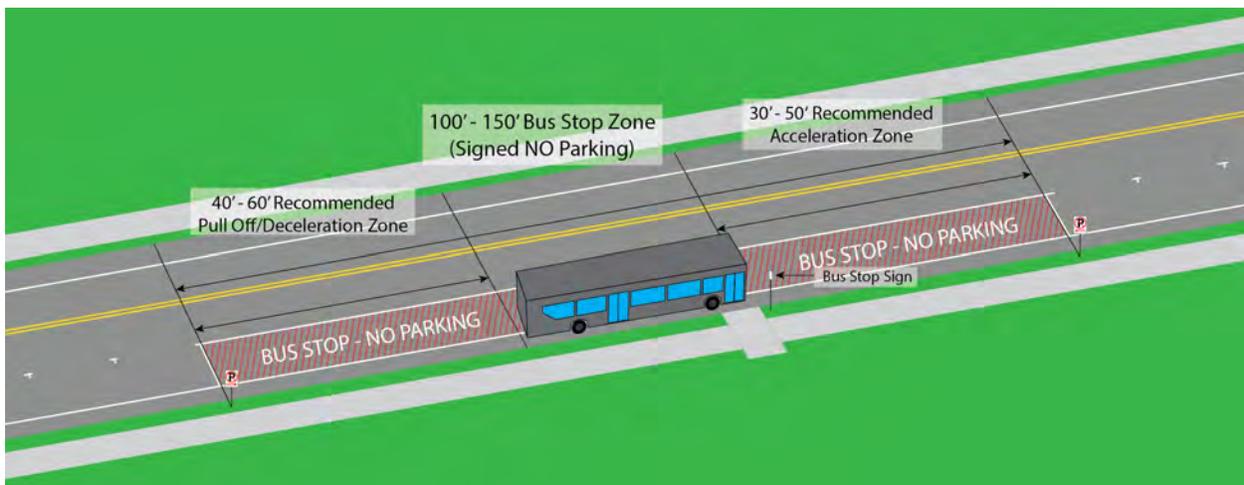
Figure 3-6: Design Considerations for Bus Stops in Parking Lanes

Similar to bus stops in parking lanes, a no parking zone would need to be designated and signed along the road's shoulder. The no parking zone should also allow adequate space for the buses acceleration and deceleration areas. It is recommended that there be at least 60' signed as no parking behind a stopped bus.

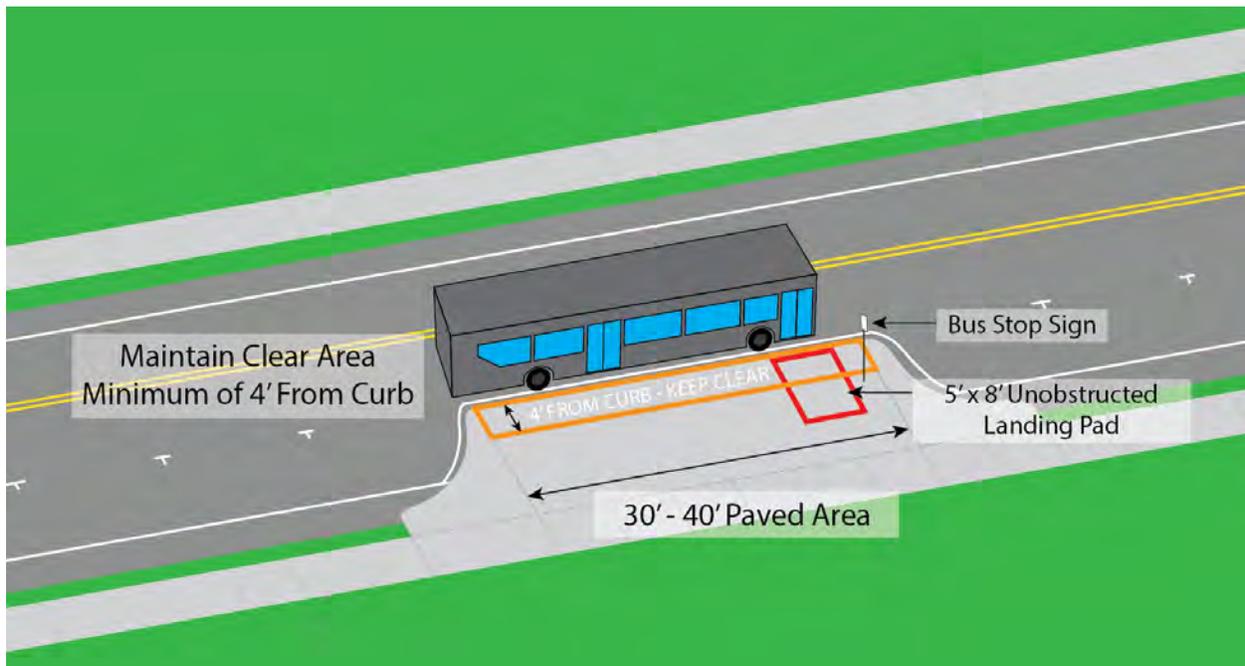
Figure 3-7: Design Considerations for Curb Bulb Bus Stops

Sometimes referred to as curb extensions, sidewalk extensions, or bulb-outs, curb bulbs are used at locations with curbside parking. A portion of the sidewalk extends out to the travel lane, thus allowing most of the curbside parking to remain while providing a connection between the travel lane and the sidewalk. Curb bulbs maximize the amount of on-street parking around bus stops while minimizing needed curb clearances.

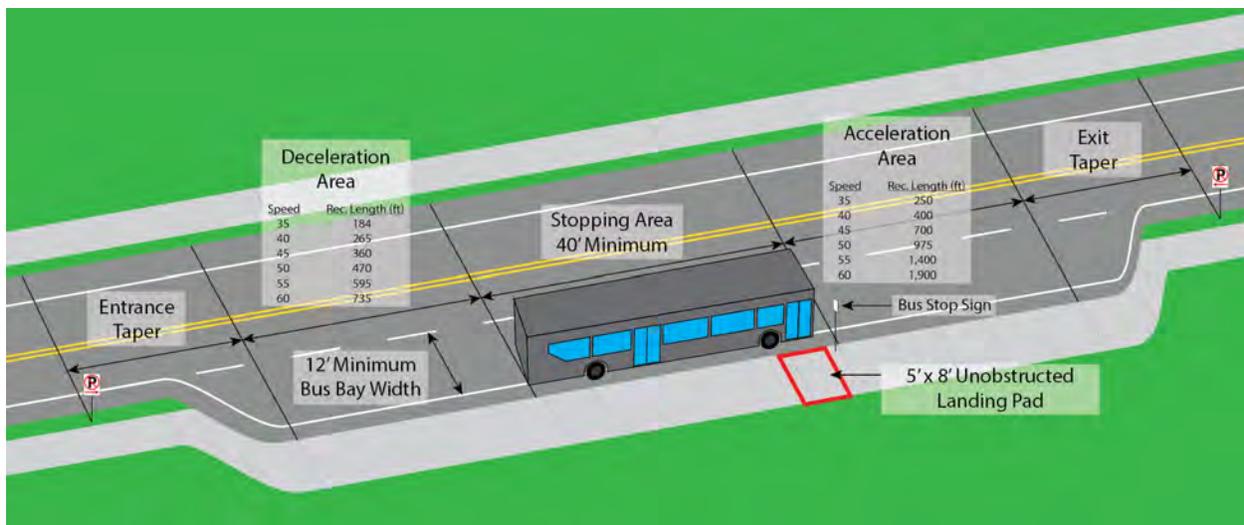
Figure 3-8: Design Considerations for Bus Bay Bus Stops

Bus bays allow buses to pick up and drop off passengers outside of the travel lane. As a result, this allows traffic to flow unobstructed while the bus is stopped. While there are various types of bus bays, parallel bus bays are most common outside of designated transfer centers. Parallel bus bays are constructed as an inset into the curb. Parallel bus bays can be closed or open; where closed bus bays have tapered ends for acceleration and deceleration and open bus bays have one end tapered and one end that continues as a through lane.

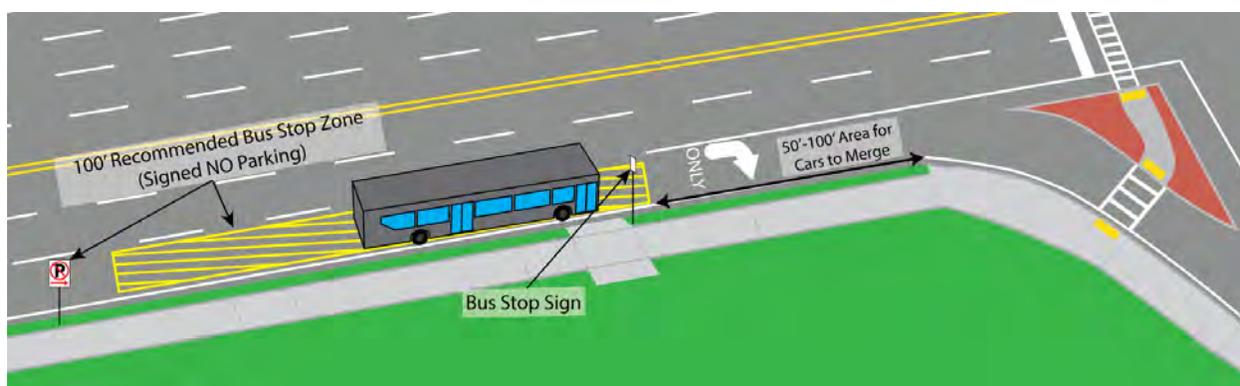
Figure 3-9: Design Considerations for Bus Stop Demarcation

One option to increase safety for bus drivers and passengers is to designate bus stop zones through on-street hatch lines, curb striping, and other visual methods. Demarcating where bus stops are located can help increase safety for vehicles on the road, providing a clear, visual indication that buses will stop within the bus stop zone. In right turn only lanes, using bus stop zones can improve congestion and traffic clarity by creating a no-merge area for other cars, increasing safety for riders who are boarding and alighting. Creating dedicated bus stop lanes are the final evolution of demarcating bus stop zones, and is a potential solution if there is increased congestion that slows transit on major thoroughfares, like Three Notch Road.

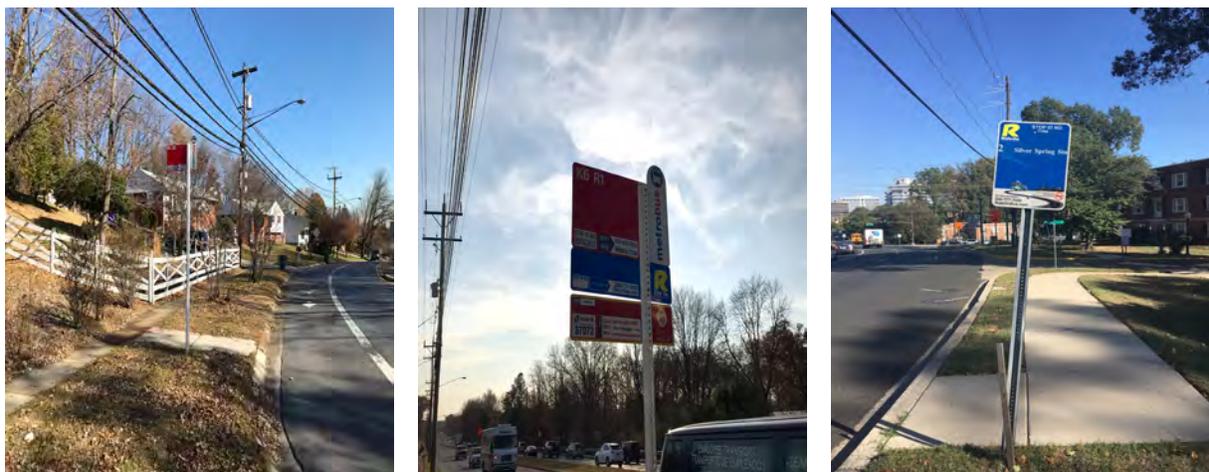
Figure 3-10: Bus Stop Sign Design Examples

Shown in Figure 3-10, from the left, the first Metrobus sign is effective in its simplicity. White text on the red background provides the proper contrast to make the sign readable for passengers. The middle image is a stop served by three transit providers; each uses a unique branding and specific route information for customers. The right image is an example of an older RideOn sign that, while effective, is rather large considering the information being conveyed.

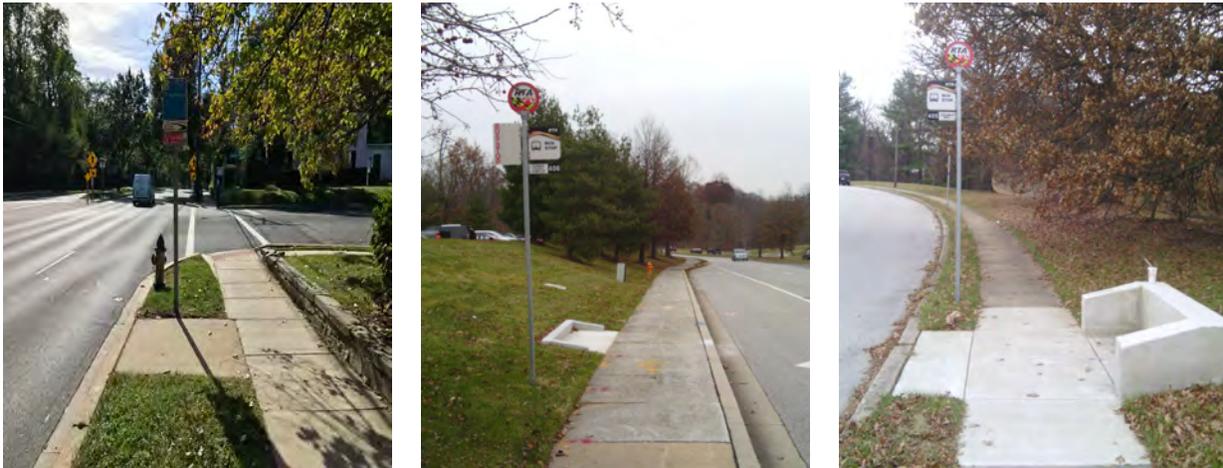
Figure 3-11: Landing Pad & Sidewalk Design Examples

The three images in Figure 3-11 demonstrate the different ways that landing pad installation is influenced by existing sidewalks and adjacent land conditions. The left image shows a landing pad developed by placing a new sidewalk panel in the grassy buffer between a sidewalk and the curb. In areas without landscape buffers, the landing pad would extend opposite of the curb as shown in the middle image. The right image shows a landing pad with a knee wall which provides protection from erosion accumulation or as a backstop for landing pads backing up to a steep ditch.

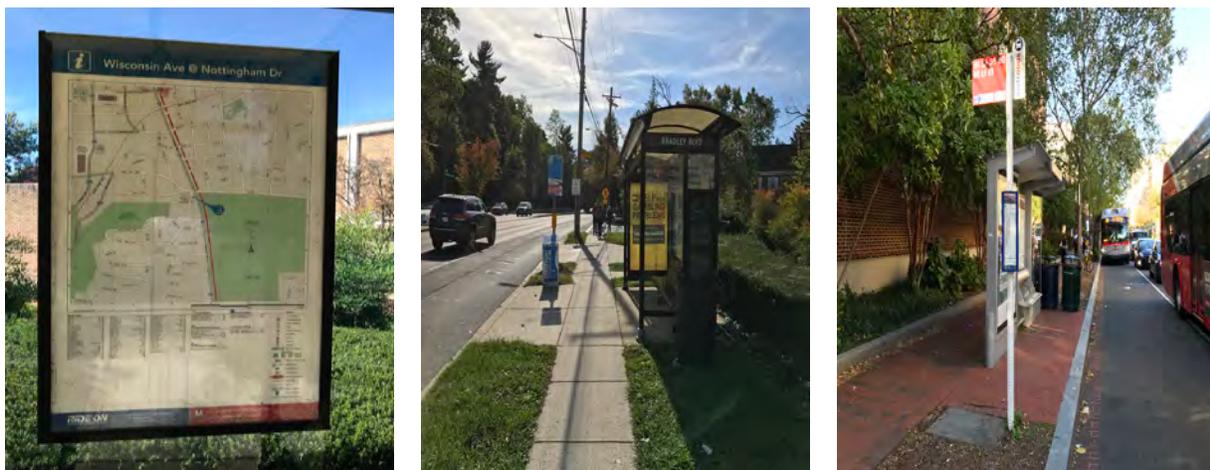
Figure 3-12: Shelter Design Examples

The images included in Figure 3-12 show different shelter styles and amenities to consider during the implementation process. The left photo shows a map on the inside of a shelter that provides information about the surrounding area, helping direct passengers to their desired locations when they get off the bus. The other two images show two different shelter designs that are influenced by their respective location's street design. The middle image displays a larger, standard shelter that sits behind the sidewalk. The right image shows a shelter installed in a denser area with high levels of pedestrian traffic. It saves space by cantilevering its cover and limiting the side panels.

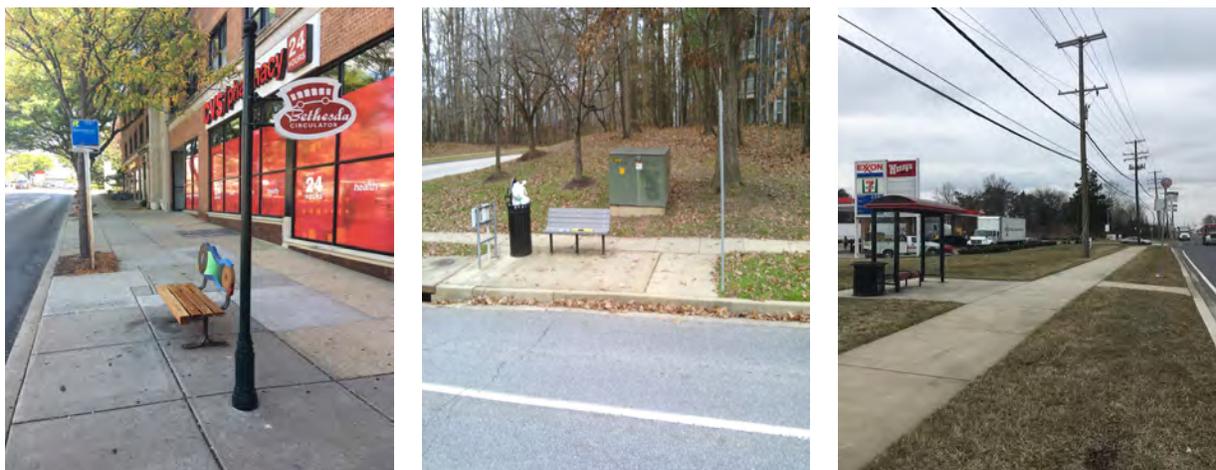
Figure 3-13: Bench Design Examples

The images included in Figure 3-13 demonstrate different bench designs. From the left, the first two images show two different freestanding benches. The first image shows an artistically designed bench that adds an attractive design element to the sidewalk. The second image is a more standard type bench located next to an ADA compliant landing pad. The right image includes a sheltered bench that is attractively designed and provides the proper 30" by 48" wide clear area within the shelter interior.

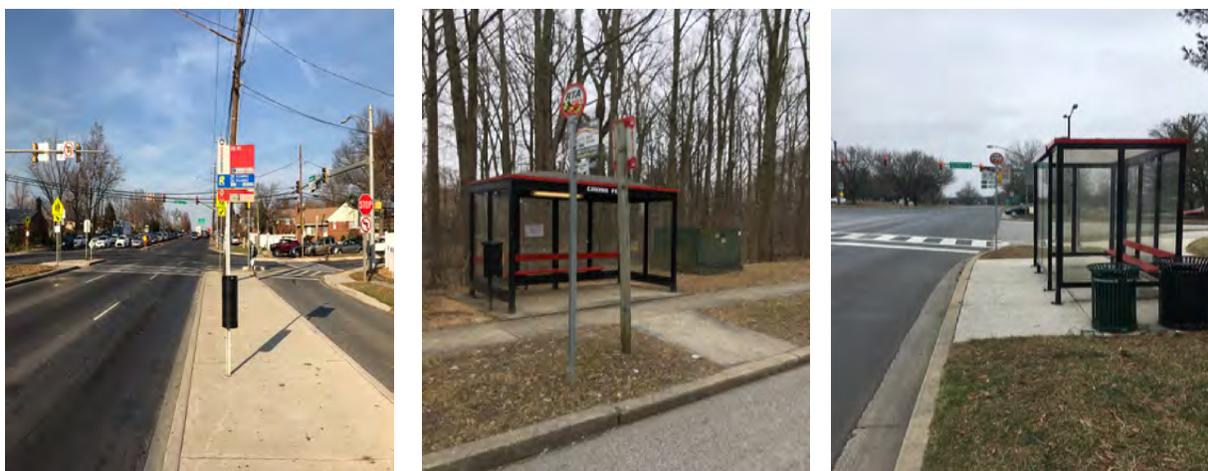
Figure 3-14: Trash Receptacles Design Examples

The images in Figure 3-14 demonstrate the ways that trash receptacles can be installed to avoid blocking the landing pad or sidewalk. From left, the first image shows a small receptacle hanging from a bus stop pole. The second image shows a hanging receptacle on a shelter. These small receptacles are an attractive and space efficient option for stops with lower activity. The third image shows larger trash and recycling receptacles placed on a patch of concrete adjacent to the shelter and landing pad, this design is useful at stops with high traffic that are more likely to produce trash.

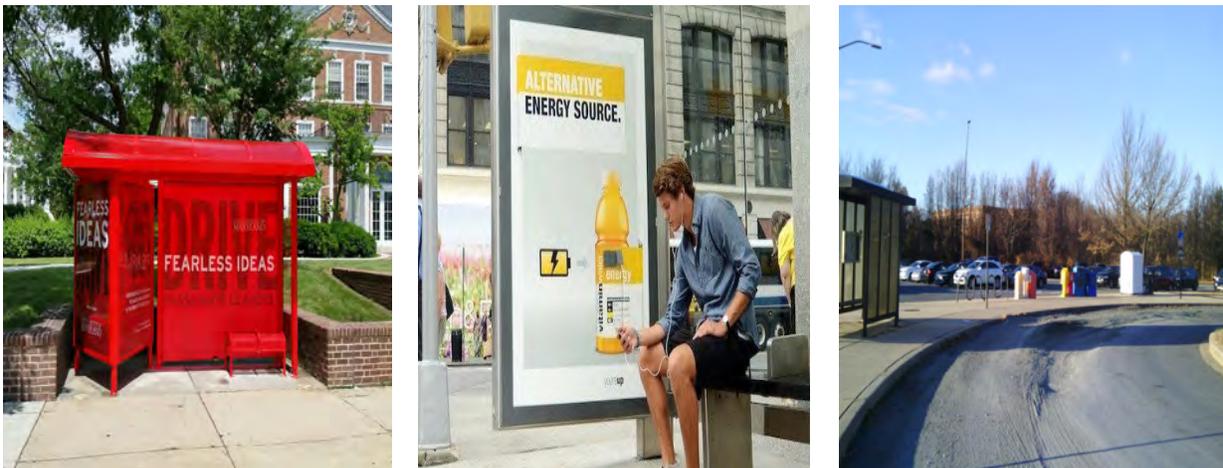
Figure 3-15: Other Amenity Examples

The images above provide examples of these different amenities in practice. The first image shows an advertisement wrap around a shelter. Partnerships with advertisement agencies can generate profits and be used to offset the installation costs associated with shelters. The second image shows an advertisement that provides a USB charging port as part of its campaign. USB charging is an especially useful amenity for people who need to transfer or have a longer ride-time. The final image shows bike racks and vendor publication boxes at a Park-&-Ride. This stop demonstrates how bicycle racks at larger bus stops can facilitate improved first and last mile connections for individuals who are not driving a personal vehicle. Vendor publication boxes provide ample marketing opportunities and provide riders with something to keep them occupied during their wait time.

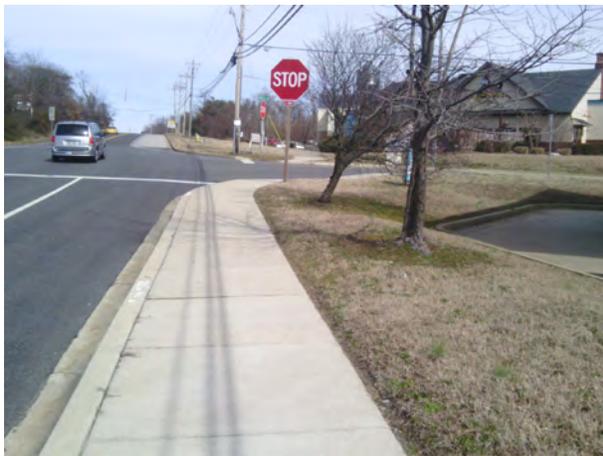
HG Trueman Rd @ Dowell Rd
Solomons

Basic bus stops are typically found in single-family neighborhoods, smaller retail centers, and other low-density areas. Heavy ridership or proximity to unique locations may necessitate additional passenger amenities including seating, trash receptacles, information cases, and shelters.

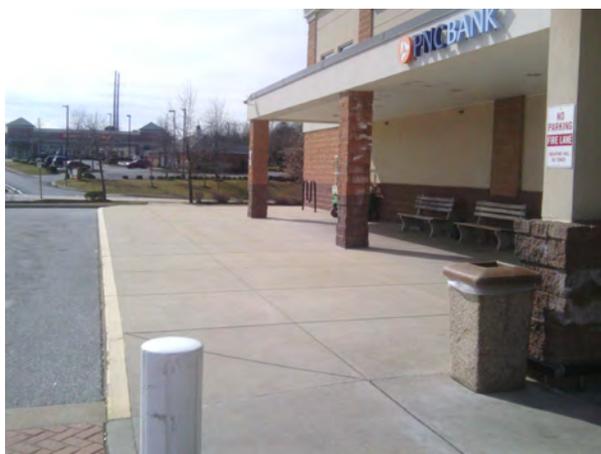
Giant Food
Lusby

The observed enhanced stops were mostly located in and around shopping centers and community centers in Lexington Park and California. Of the 106 observed stops, 40 (38%) were considered to be enhanced bus stops.

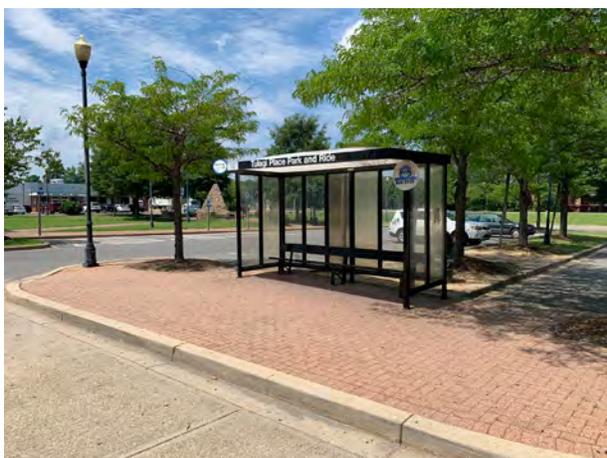
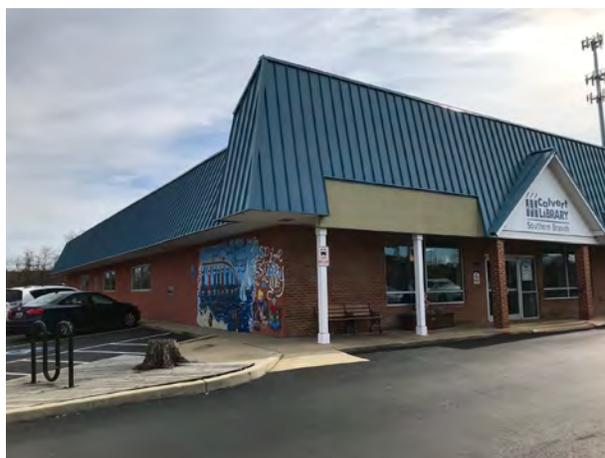
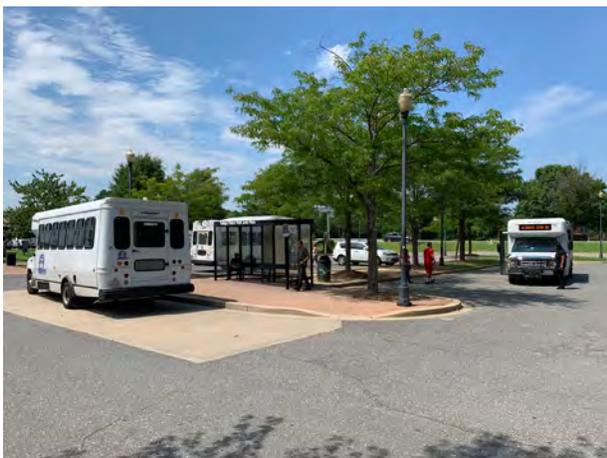
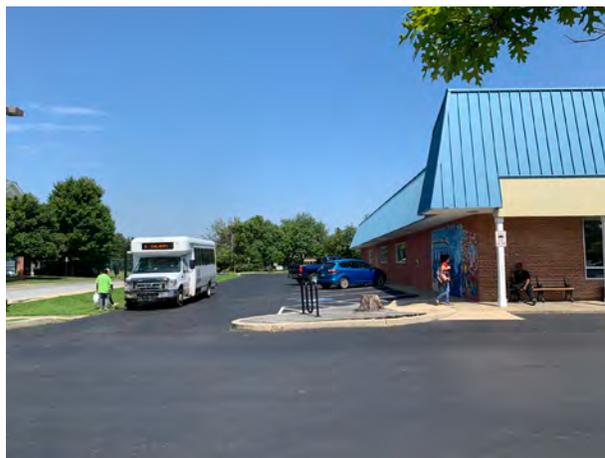
Figure 3-19: Transit Center Examples

Transit centers are the most important bus stops within a transit system. They typically exhibit high ridership activity and allow passengers to transfer to other routes or other transportation services. These can include defined transfer centers, park-&-ride lots, and major stops at hospitals or shopping centers. In the C-SMMPO area, two stops met these criteria; the Tulagi Place Park-&-Ride and the Calvert Library Southern Branch. Tulagi Place is one of the main transfer locations for STS and the Calvert Library is the transfer point between CCPT and STS.

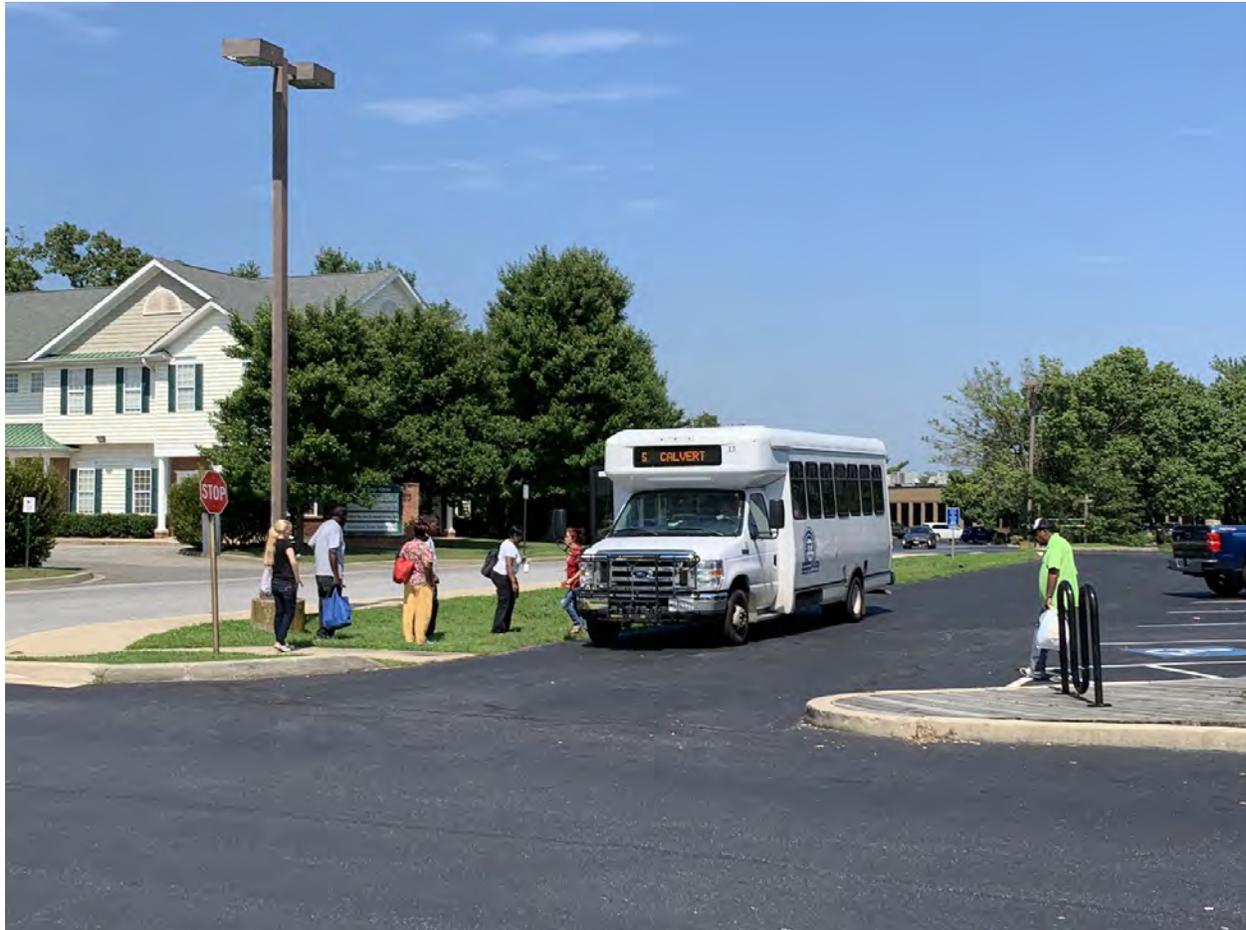
Figure 3-20: Passengers Board and Alight in a Grassy Area

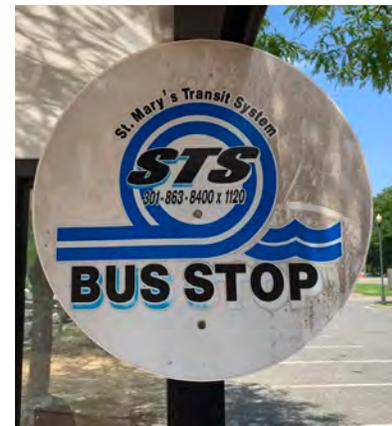
Figure 4-1: Updated Bus Stop Signs are Needed

Under ADAAG bus stop sign compliance (see page 4), text characters cannot be italic oblique. Transit agency logos are typically excluded from this standard; however, the STS logo includes contact information (phone number) that is italic oblique. Both CCPT and STS should consider updating their bus stop signs with clear and enhanced branding.

Installing bus stop accessibility improvements can be costly and time-consuming. Therefore, it is recommended that the local transit systems or jurisdictions install bus stop signage ahead of accessibility improvements given the current lack of signage. However, it should be stressed that the vast majority of these stops will not be compliant with ADA guidelines and an implementation plan should be in place to guide the future installation of accessibility improvements at these locations.
