Calvert-St. Mary's
Metropolitan Planning Organization's

Bus Stop Assessment and Plan

Final Report
September 2019

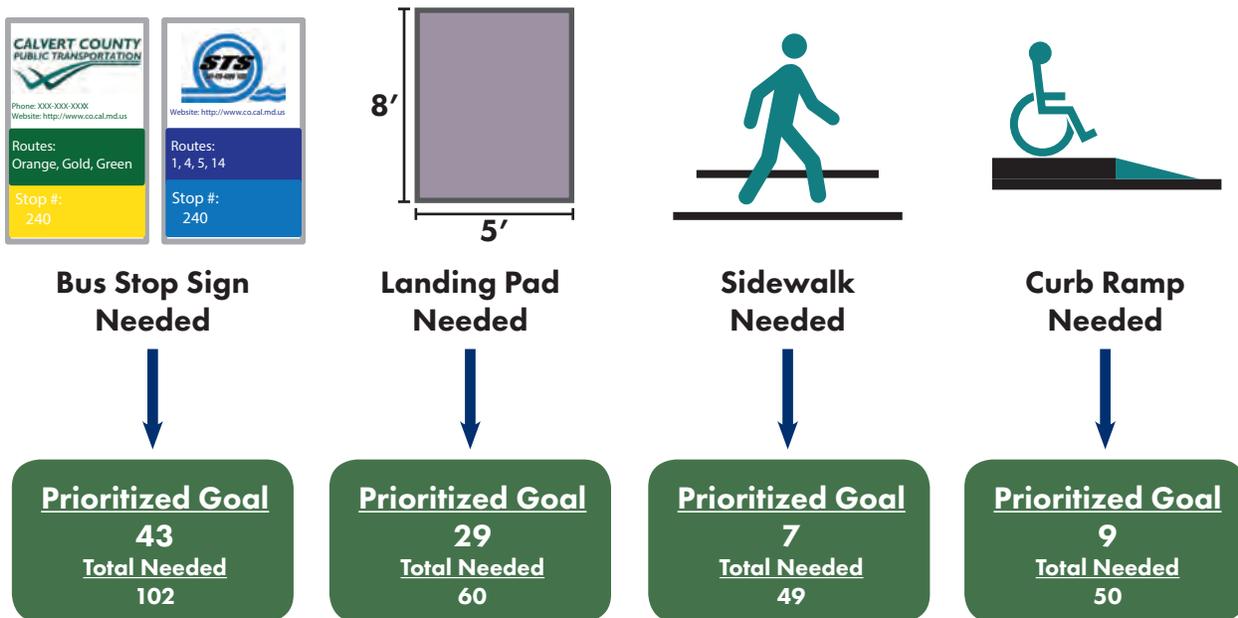
Figure 4-3: Basic Bus Stop Improvement Summary

Implementing these improvements will lead to ADA compliance at each bus stop. The improvements will also provide a safe and inviting experience for transit customers; especially individuals who rely on mobility assistance devices. Detailed in Figure 4-3, a total of 47 bus stops were identified and recommended for basic bus stop improvements.

Basic bus stop improvements include bus stop signage and the accessibility elements defined by the ADA Guidelines detailed in Chapter 1. Under the ADA Guidelines, each bus stop must include the following basic amenities and accessibility improvements:

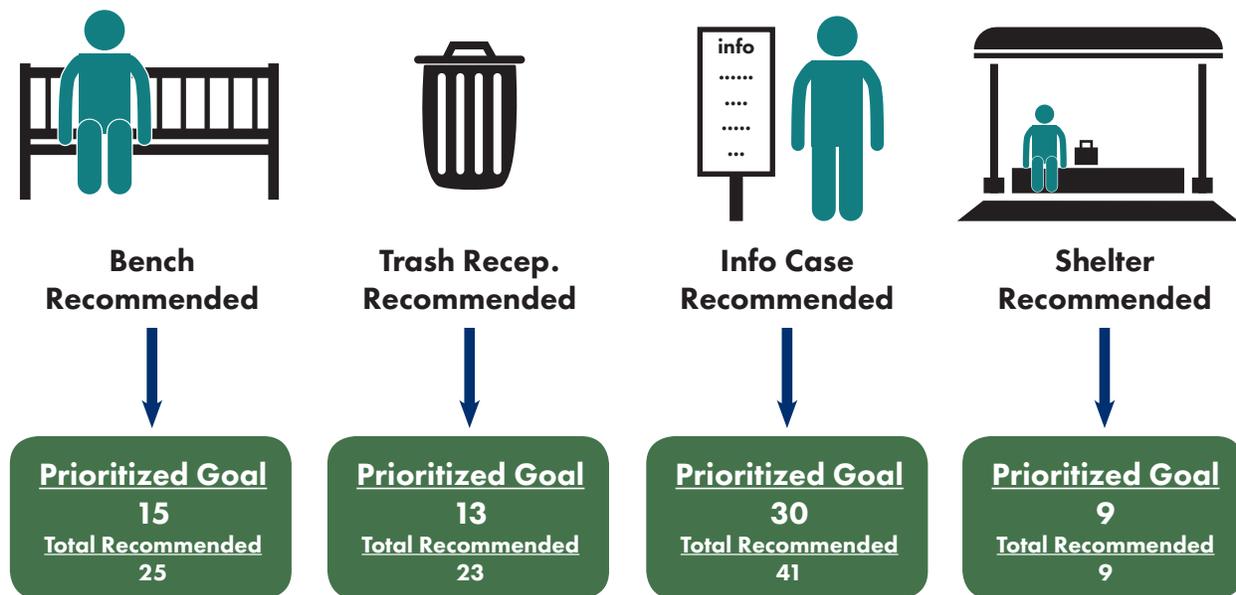
Figure 4-4: Enhanced Bus Stop Improvement Summary

Many enhanced bus stops still need basic improvements. Of the 29 enhanced stops recommended for improvements, 14 require an ADA compliant landing pad, one stop lacks a curb ramp and 13 stops require an updated curb ramp with a detectable warning.

Enhanced bus stops include additional customer amenities like seating and shelters. Amenities like benches, information cases, and trash receptacles should be placed at enhanced service stops whenever and wherever feasible. Bus shelters should be placed at bus stops that average 25 or more average daily boardings. Figure 4-4 displays the number of recommended improvements broken out by prioritized goals and the number of improvements needed at all 106 bus stops. Appendix B contains a table showing the improvements required at each individual bus stop.

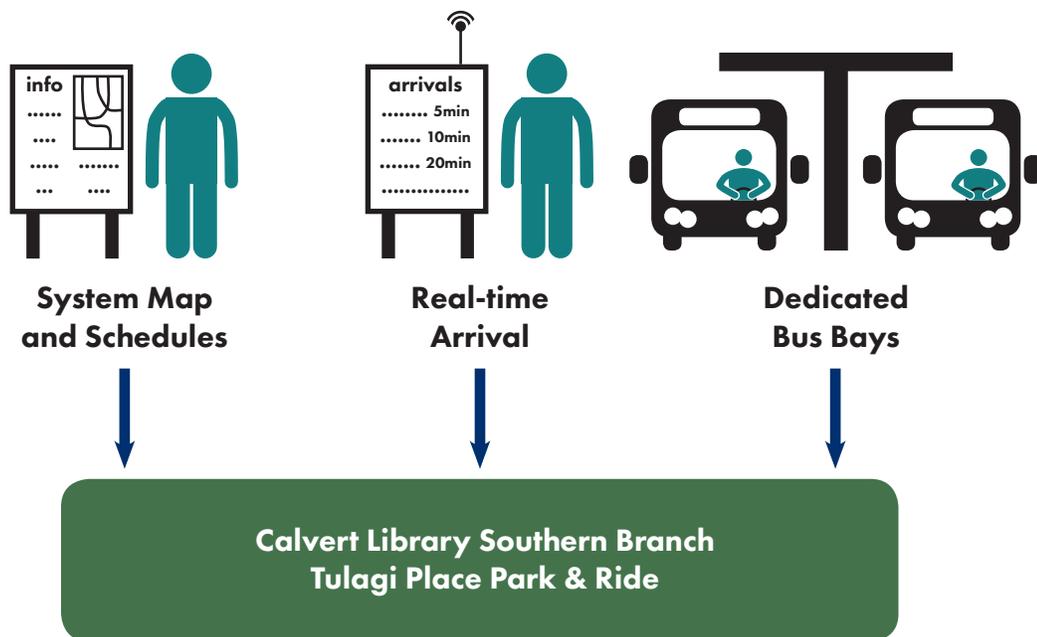
Figure 4-5: Transit Center Improvement Summary

Other than transit center level improvements, Tulagi Place requires two new detectable warning strips for the two curb ramps connected to the landing pad and an information case. The Calvert Library Southern Branch also requires a detectable warning; an information case and trash receptacle are also recommended.

Transit centers should be approached on a case-by-case basis but should generally include all of the customer amenities recommended for basic and enhanced service stops. In addition, transit centers should feature information cases with system maps, connecting bus schedules, and real-time arrival information. Dedicated bus bays with large passenger waiting areas are also recommended but not included in the scope of this study.
